RECLAMATION DISTRICT NO. 1601 TWITCHELL ISLAND BOARD OF TRUSTEES MEETING TUESDAY, NOVEMBER 19, 2024 9:00 AM ENGINEER'S REPORT

I. LEVEE DISTRESS AT LEVEE STATION 60+00 ALONG THREE MILE SLOUGH

EXHIBIT A: Field photography from KSN Inc's Daily Field Reports.

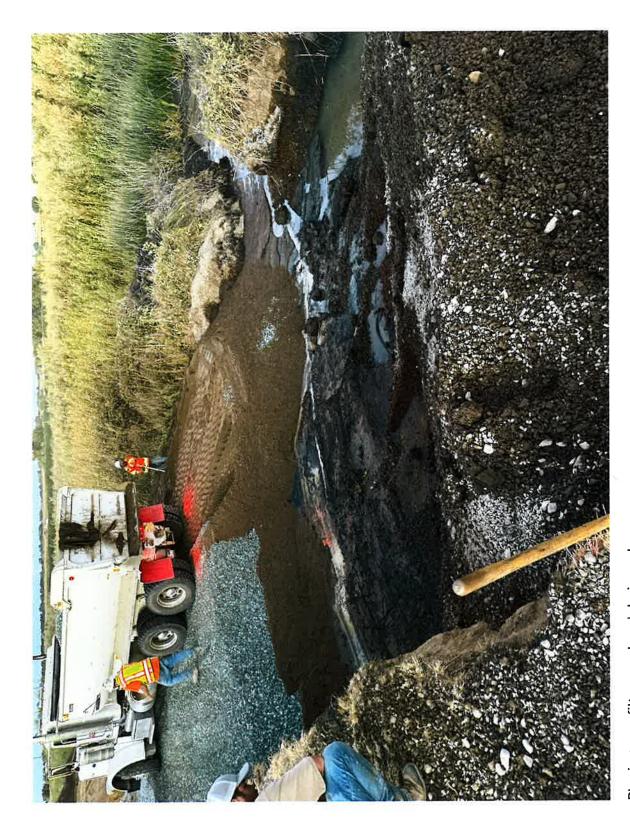
Placing new filter sand and drain rock

- c) Excavated existing drain rock (up to 5' thick). Removed the bottom layer of existing fabric.
 - d) Placed new filter sand (1'-3') thick) and new drain rock $(\pm 2')$ thick).
